**WALNUT HOLLOW LAKE DAM
IRON COUNTY, MISSOURI
MO 30619**

**PHASE 1 INSPECTION REPORT
NATIONAL DAM SAFETY INSPECTION**

**Phase I Inspection Report
National Dam Safety Program**

Name of Dam	Walnut Hollow Lake Dam
State Located	Missouri
County Located	Iron
Stream	Unnamed Tributary of Big Creek
Date of Inspection	11 November 1980

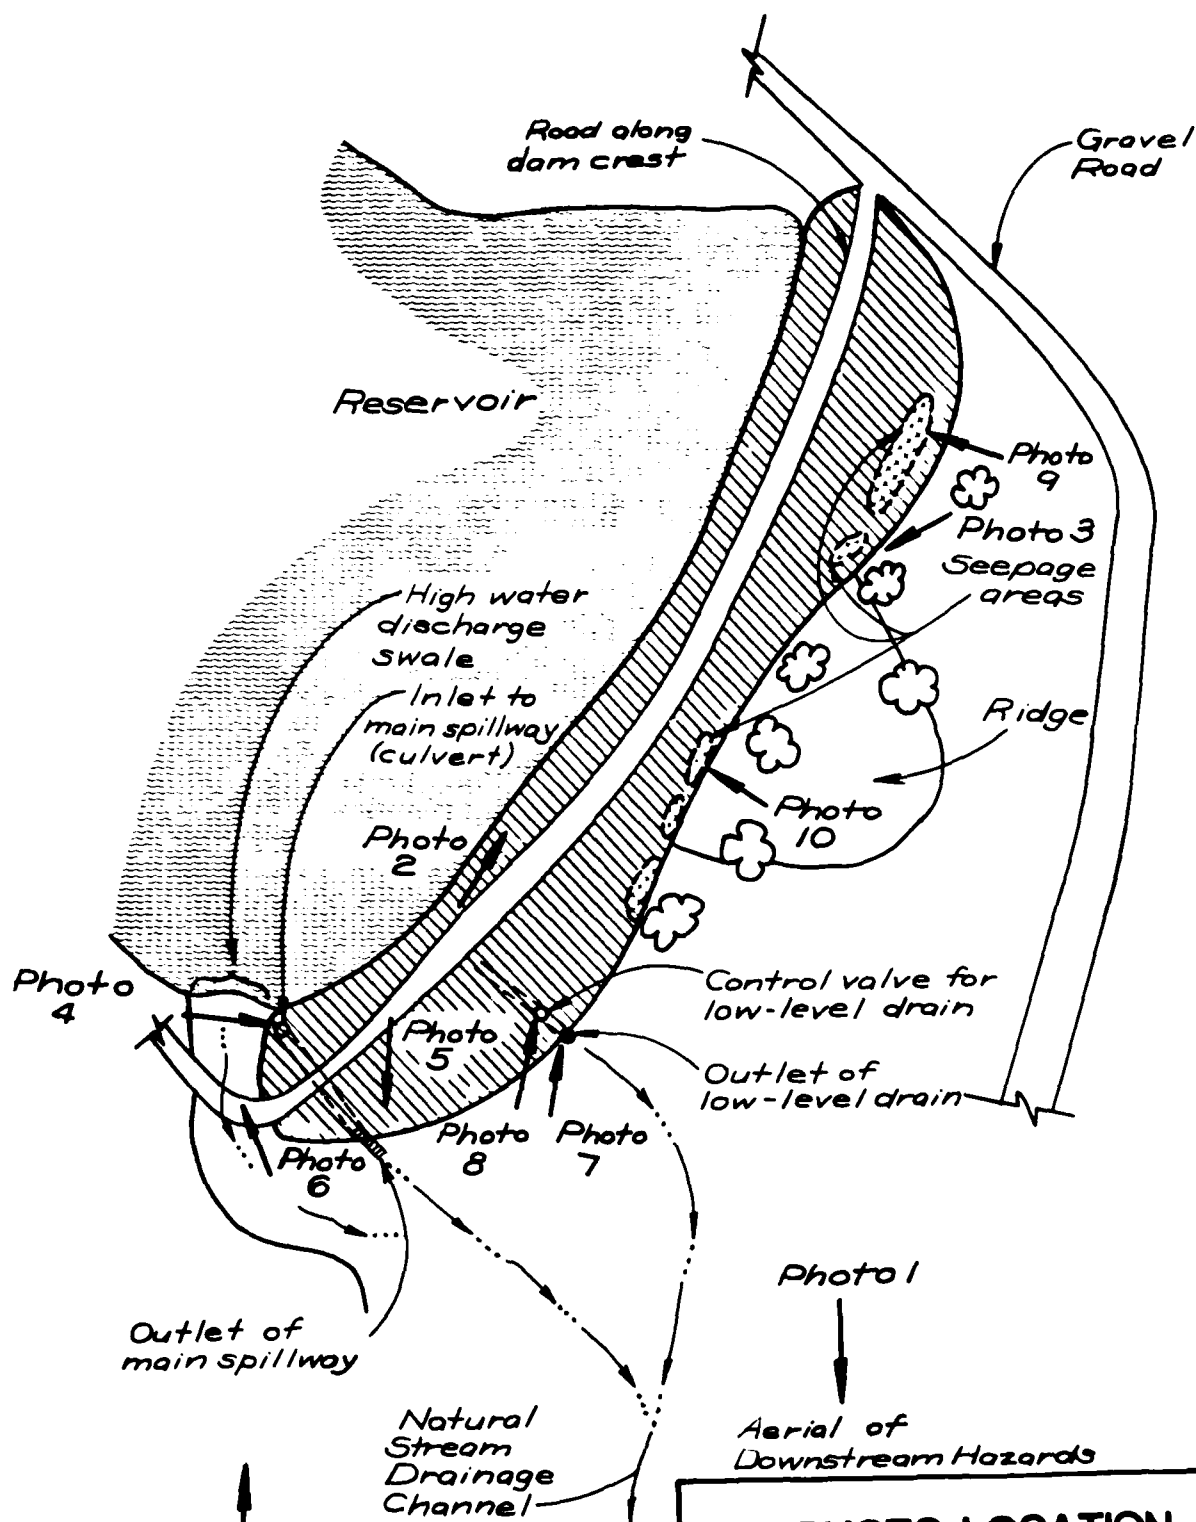
Fig. A-1

Slow seepage was observed in several locations along the toe of both high portions of the dam embankment (Fig A-1 and Photos 9 and 10). The seepage was slow and was estimated at about 1 to 2 gpm in each location with the total flow of about 10 gpm. Substantial algae growth was observed at the points of seepage at the time of inspection. Seepage did not appear to be transporting any soil particles. The reservoir surface was about 6 ft below the spillway crest at the time of inspection.
